# Manhole Inspection Summary

Manhole # S13Q\_\_020MH

**Location** Address: **3100 Wilkens**

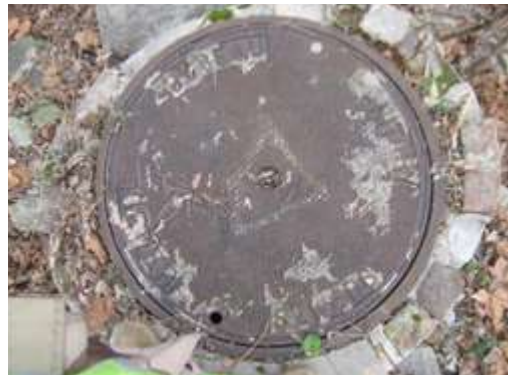
cover pic

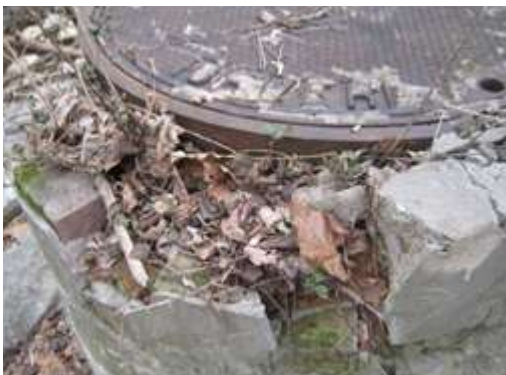
defects on mh

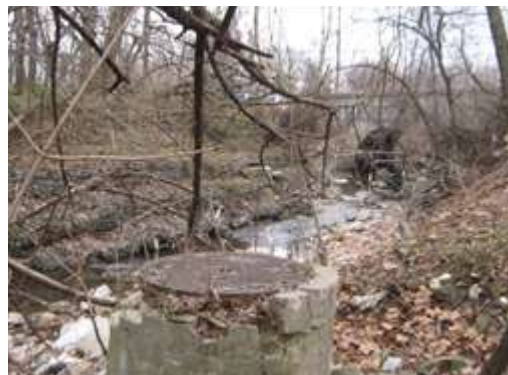
loc 2

missing bricks

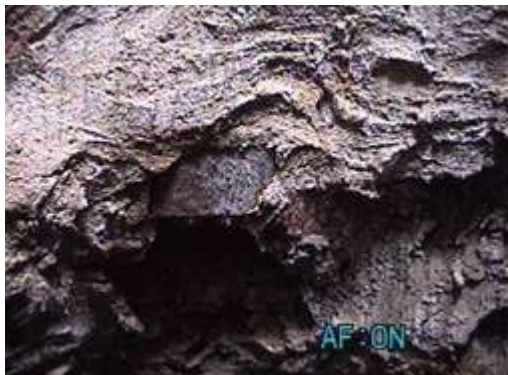
repairs

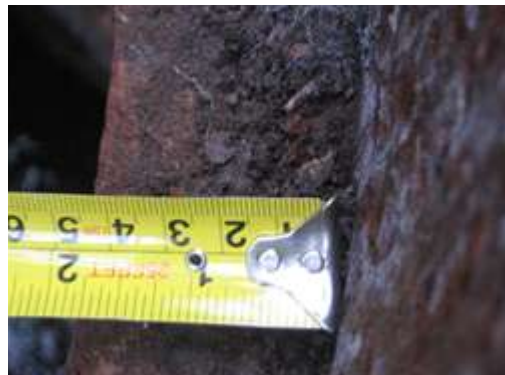
Defect

repairs in barrel

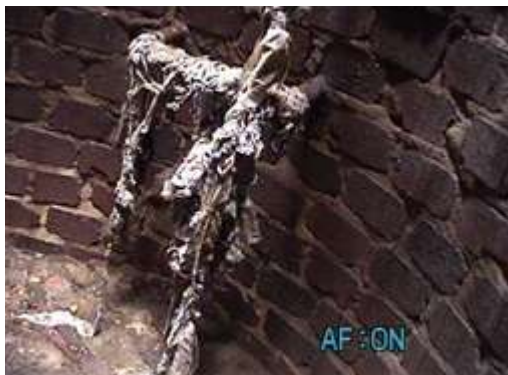
Defect 6

Offset

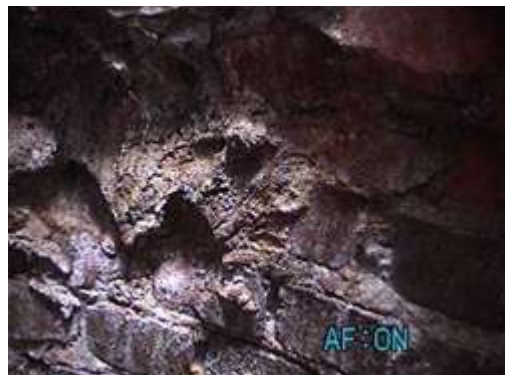
Defect 5

debris between rungs

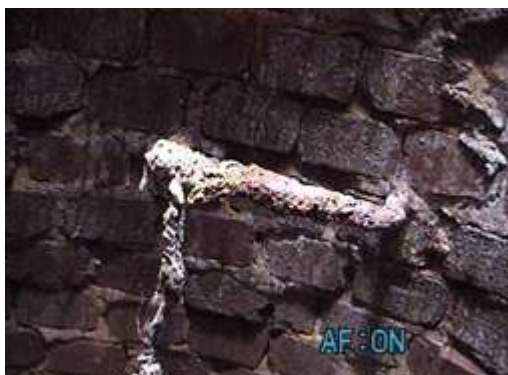
Defect 4

Condition: ☐ Sound ☒ **Cracked** ☐ Root Intrusion ☒ **Loose Brick** ☒ **Deteriorated**

Infiltration: ☐ None ☐ Joint ☒ **Cracks** ☒ **Mortar** ☐ Roots ☒ **Wall**

missing bricks , mortar and infiltration barrel area

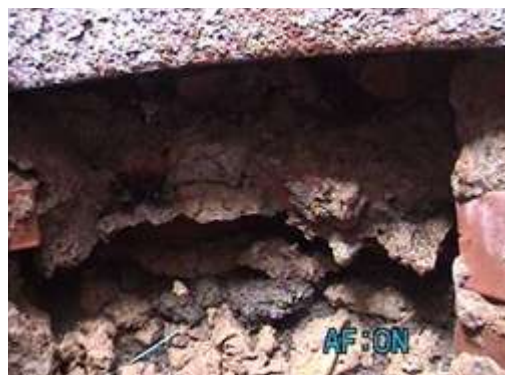
Defect 3

**Steps** Count: **5** Missing: **1** ☒ **Corroded**

**Surcharge** ☒ **Evidence Of Surcharge** Depth: **4** (ft.) ☐ Active Surcharge Present

corroded rung, signs of surcharge

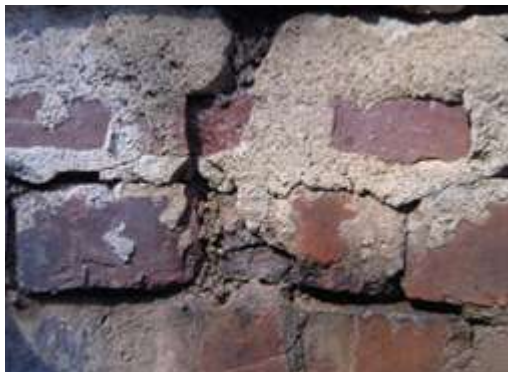
Defect 2

Condition: ☐ Sound ☒ **Cracked** ☐ Root Intrusion ☒ **Loose Brick** ☒ **Deteriorated**

Infiltration: ☐ None ☐ Joint ☒ **Cracks** ☐ Mortar ☐ Roots ☒ **Wall**

missing bricks, mortar, as well as infiltration corbel

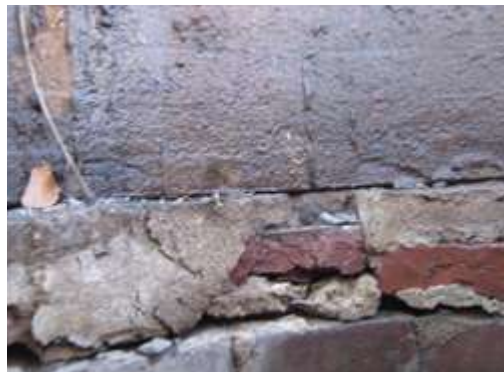
Defect 1

corbel missing mortar cracked bricks
